## Steps To **GREEN** Homes

Adam T. Hayes

## Infrared Scans with Photographs

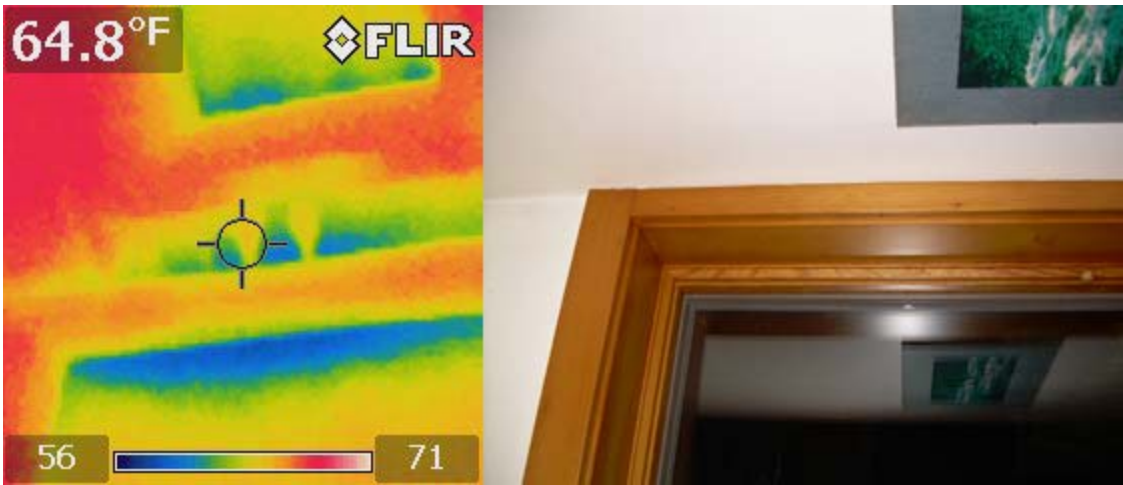
Window Trim

10. Most old widow casings have air-leaks above heads (visible cracks, infrared photo)
  - Recommend – caulking
11. No damper in fireplace creating large heat loss through convection
